URBAN WATER MANAGEMENT IN KINGSTON, NY:
PLACING GREEN INFRASTRUCTURE IN TEMPORAL & SPATIAL CONTEXT

A Thesis

of Cornell University

December 2018

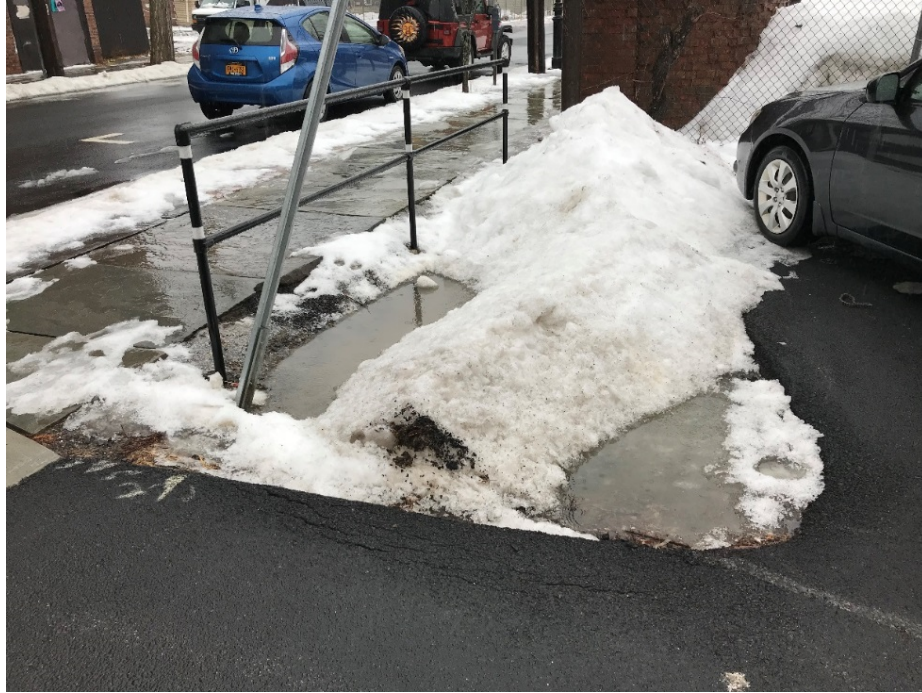
Snow was plowed toward the edges of the lots, and the bioretention areas and rain gardens provided a convenient storage location (Figure 3.37). Most of the snow from the South lot was pushed within the drainage area of Dry Well South 2, which treated a substantial amount of snowmelt (Figure 3.38). The woody vegetation in the bioretention areas was damaged from snow plowing, as previously discussed. Using the green infrastructure practices for snow storage reduced the area available to store runoff, particularly during rain-on-snow events (Figure 3.39).

Figure 3.39: Rain Garden South during a rain-on-snow event (February 11, 2018).

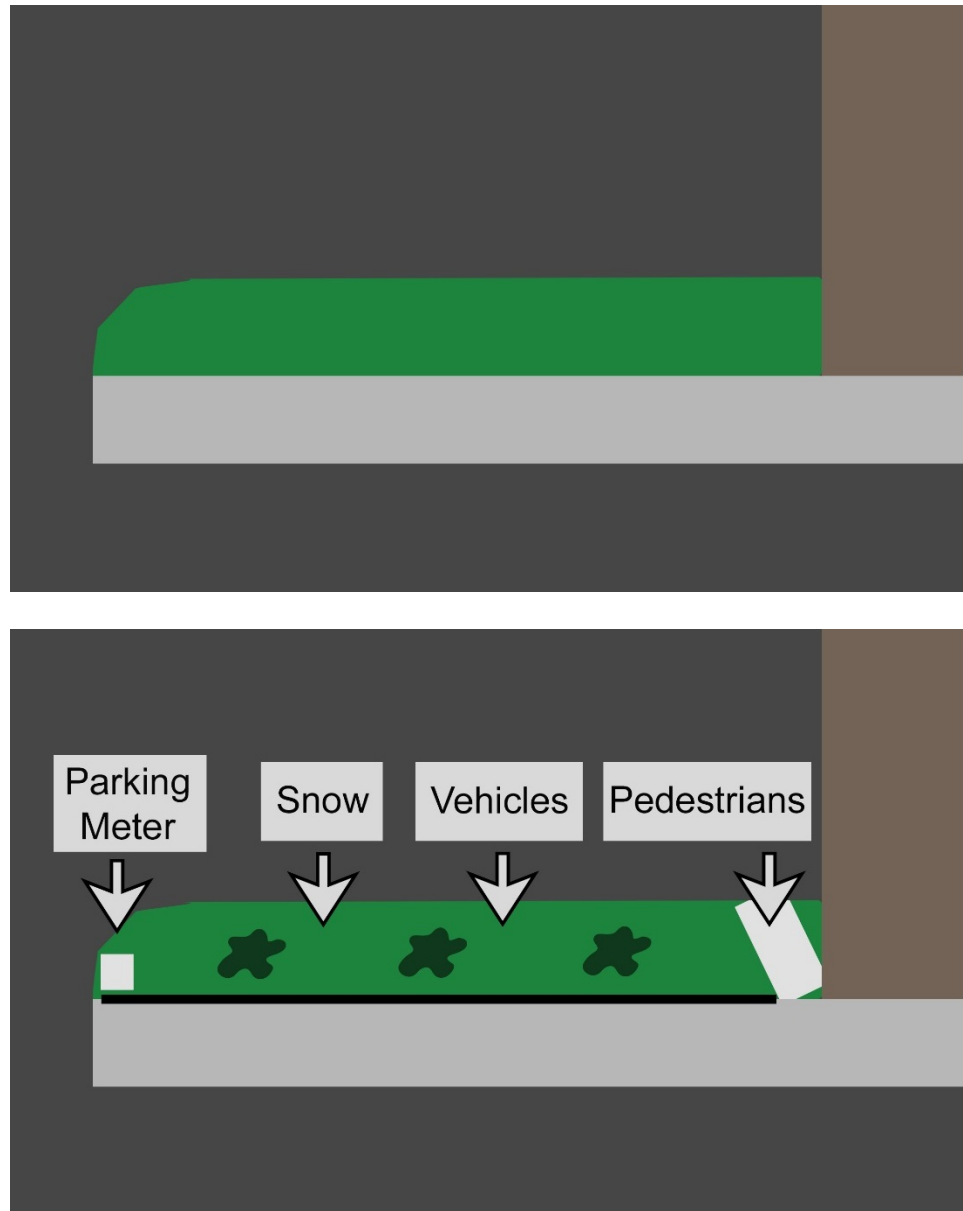
The bioretention areas were located along the edge of the parking lots, between the parking lot and the North Front Street sidewalk. Although the engineering drawings were straightforward, in reality this was an area upon which many demands were placed. The bioretention areas were designed to provide storage space for stormwater and have vegetation; fencing, a pedestrian walkway, and a parking meter were added to the practices. Vehicles drove through the edges of the bioretention areas when turning within the parking lots, or attempted to drive through them when the entrances were changed. Pedestrians crossed through bioretention areas on their way to Uptown businesses. Snow was plowed to these edges, damaging vegetation. Parking meters were also installed within the practices' storage space. Litter from the parking lots also accumulated within the bioretention areas. Figure 3.40 demonstrates the conflicts of various uses in Bioretention Area North, as an example. The bioretention areas were still able to infiltrate stormwater runoff, despite the compaction and reduction in storage area. (For more information on water level in the bioretention areas, see Chapter 2: Quantitative Assessment of Green Infrastructure.)

Figure 3:40: Diagram of conflicting uses of the bioretention areas. This shows a plan view of Bioretention North as an example. Although the engineering drawings were straightforward, and included a large storage area (top), in reality, this location had a number of conflicting demands (bottom). The green represents the bioretention area (with dark green vegetation), dark gray is the road and parking lot, light gray is the sidewalk, and brown is the adjacent building.

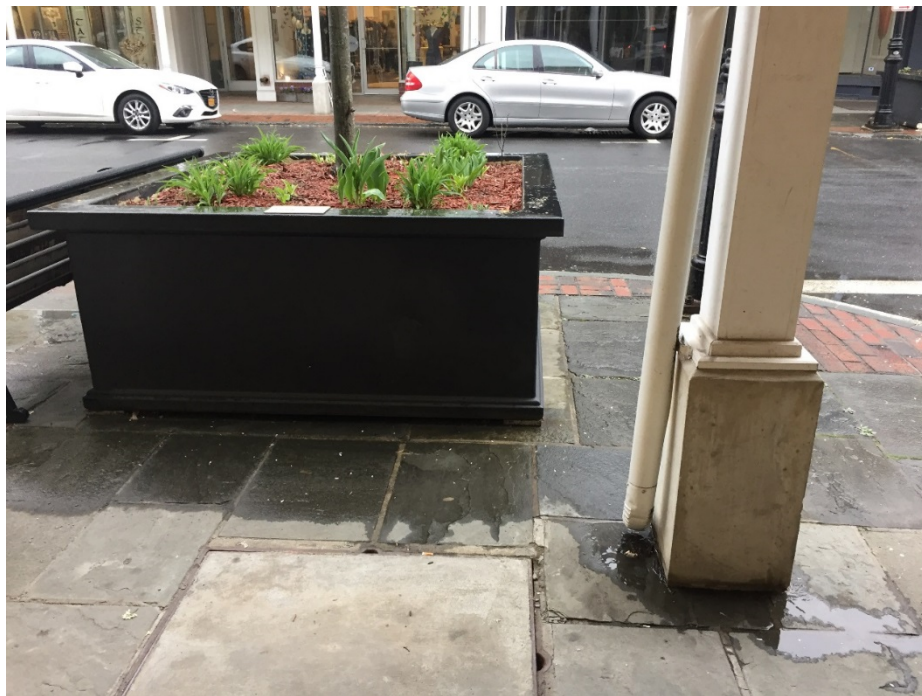
There may be other opportunities to improve stormwater management through green infrastructure retrofits throughout Uptown Kingston. Despite the density of development in this neighborhood, there are many large planters and other landscaping features (Figure 3.41). This area is well-suited to infiltration due to its sandy, well-drained soils and high depth to groundwater. This is also an important business district, and could benefit from additional vegetation. Many downspouts from the building roofs and canopies discharge directly into the sidewalk or street, and these could be redirected into green infrastructure practices, such as stormwater planters.

Figure 3.41: Large planter box on Wall Street with an adjacent downspout that discharges directly onto the sidewalk (April 19, 2017). This type of site could be an opportunity for future green infrastructure retrofits.
